Ripe for restoration

The plight of lifeless Inchewan Burn, Perthshire, was brought to SEPA's attention in 2005. Three years on salmon are jumping once more. Habitat Enhancement Specialist Steven Jarron explains how.

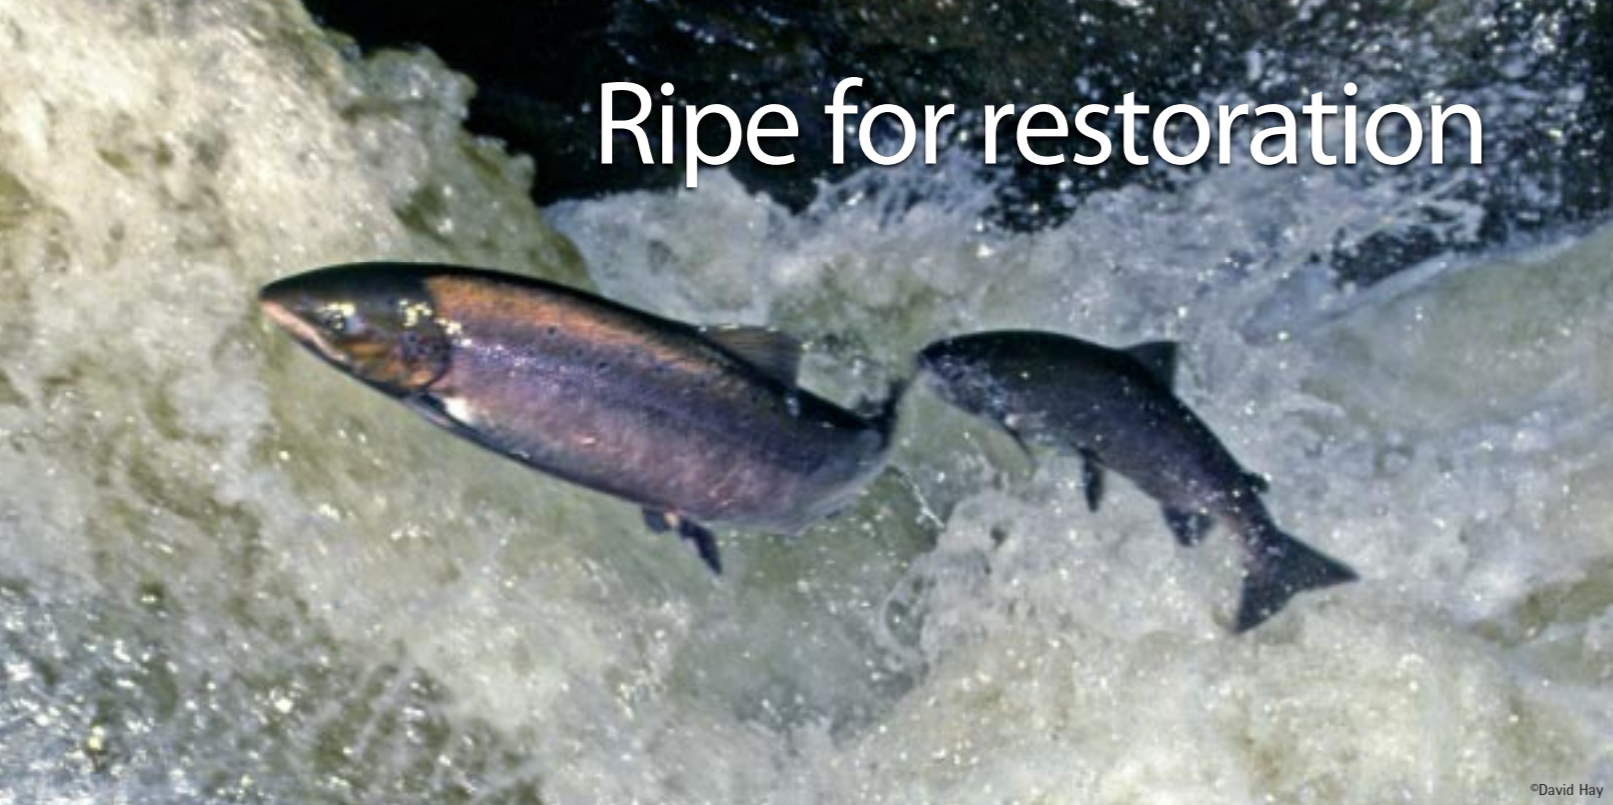
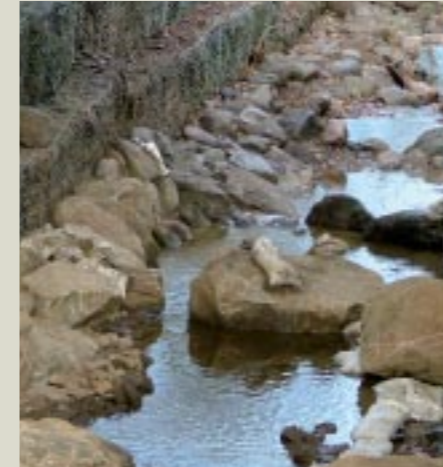
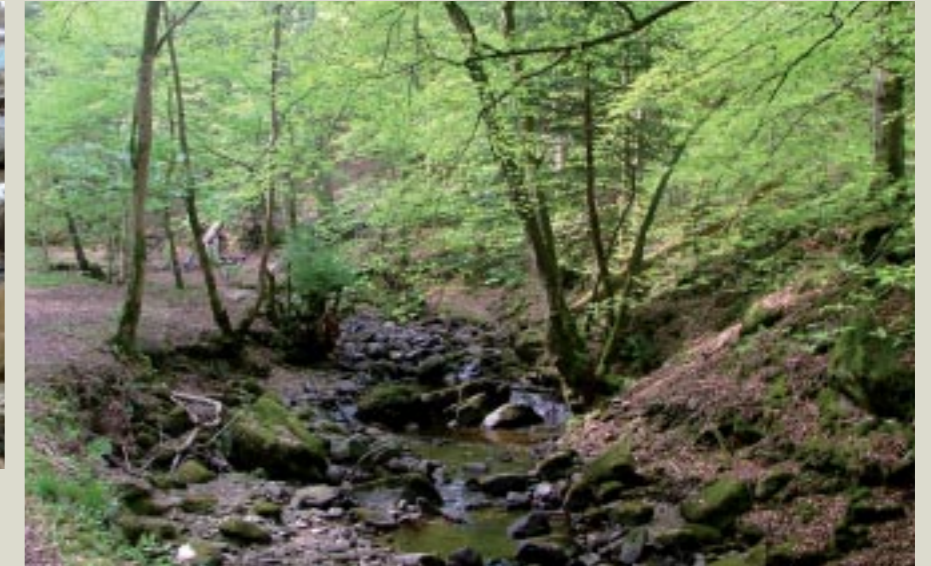
Photos from left: Salmon jumping at Buchanty Spout in Glen Almond, near Crieff; pools were created to provide shelter for fish; beech trees growing over the burn. (Restoration images courtesy of Scottish Native Woods.)

Subsequently, the reno mattresses were removed and a stone bed was engineered to prevent any possibility of undermining. A boulder bed to the river was also restored and some of the gabion baskets were removed to naturalise the visible left bank of the burn.

While protecting the water environment, the licence granted the contractor – John Langley Construction – a degree of flexibility. Langley wanted to work on the burn in a more 'artistic' way, to mimic the natural step pools further upstream, which are ideal for fish passage.
